TECHNICAL SERVICE BULLETIN

Bulletin Number: DC-2172

Affected Model(s): 87500 Bare Grease Reels and Associated
Configured Assemblies

Subject: **Tips on Axle U-Cup Replacement**

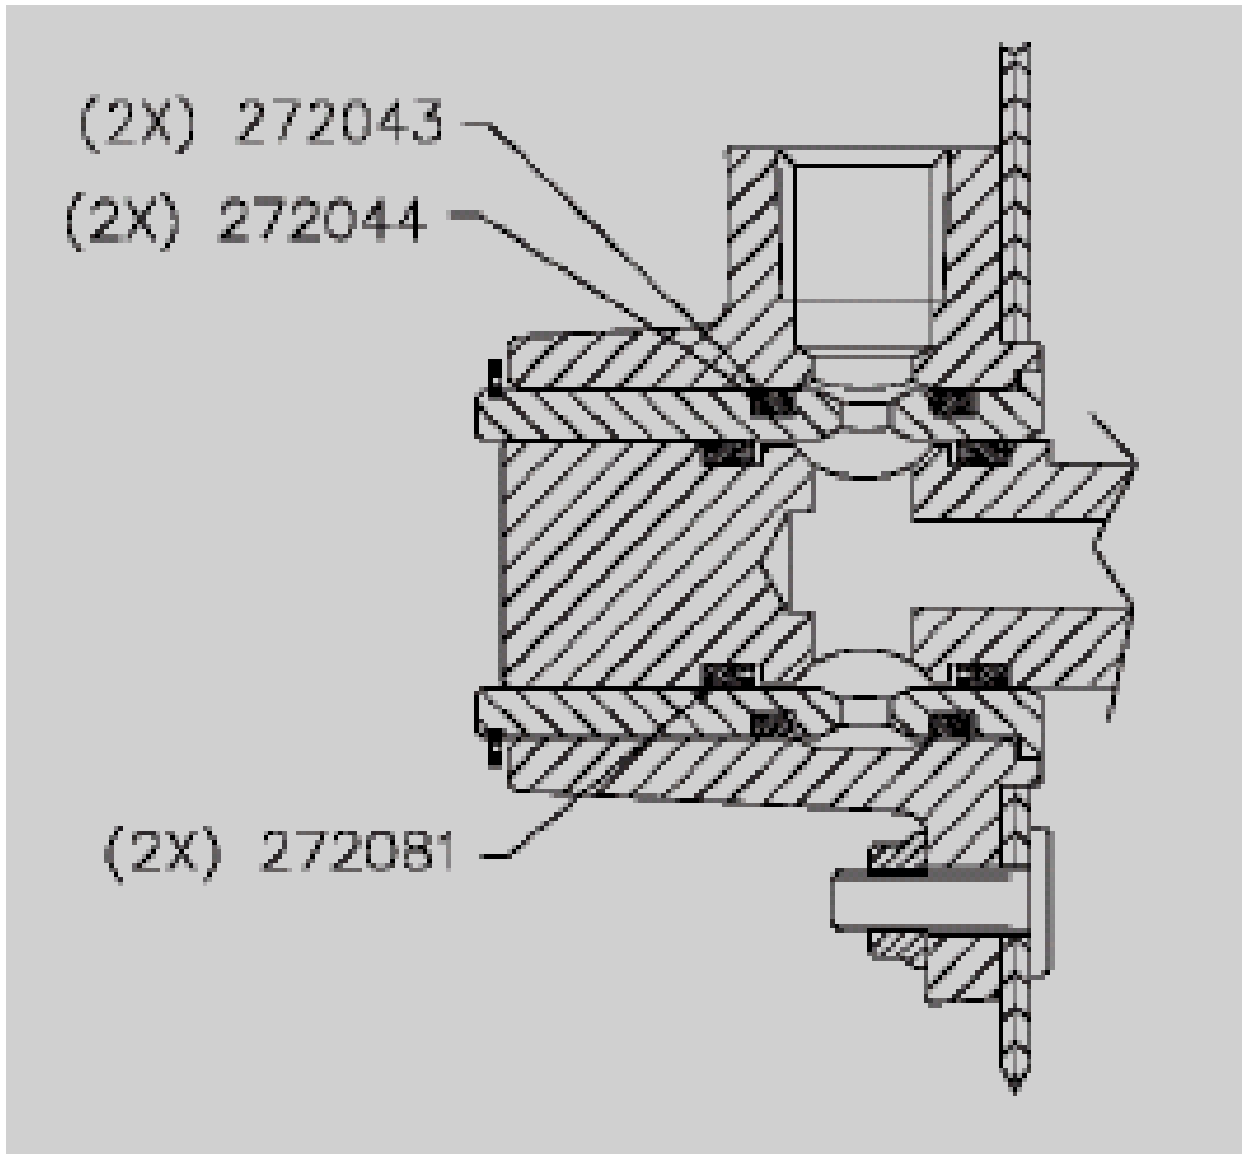
Recently it was pointed out that our current owner's manual/service page on the 87500 grease reels does not include instructions for proper replacement of the 272081 u-cup seals on the reel axle. Naturally, they must be positioned properly (opposing, heel sides out, lips toward the pressure) to prevent grease leakage while the reel is pressurized.

The reel hub, axle bushing, axle, and axle u-cups are depicted on the attached drawing pulled directly from the current service page. Please include these instructions with your service pages and refer to them accordingly to prevent future failures.

- Grease axle (272038) generously,
- Slide u-cups (272081) on to axle properly,
- Axle should be slid into the Axle Bushing (272032) from the **INSIDE**. Please note: At the point where the axle slides into the bushing, there is a 30 degree "lead in" for ease of installation,
- The first u-cup to pass into the bushing should go in with ease,
- The second u-cup should be led into the axle bushing equally around the entire circumference of the u-cup,
- Attention should be given at all times while sliding the u-cups and axle into the bushing. If there is any pinching of the u-cups during installation, there can and most likely will be grease leakage around the pinched portion of the u-cup and an immediate failure when the system is pressurized.
