TECHNICAL SERVICE BULLETIN

Bulletin Number: DC- 2256

**Affected Model(s): 3" and 4.25"-PMV Fluid/Oil Pumps
Bare Pumps-V305000000/5:1 Ratio
V406000000/6:1 Ratio
V410000000/10:1 Ratio
(See **Attachment 1** for Listing of Affected Models)**

Subject: Pump Tube Loosening from Outlet Body

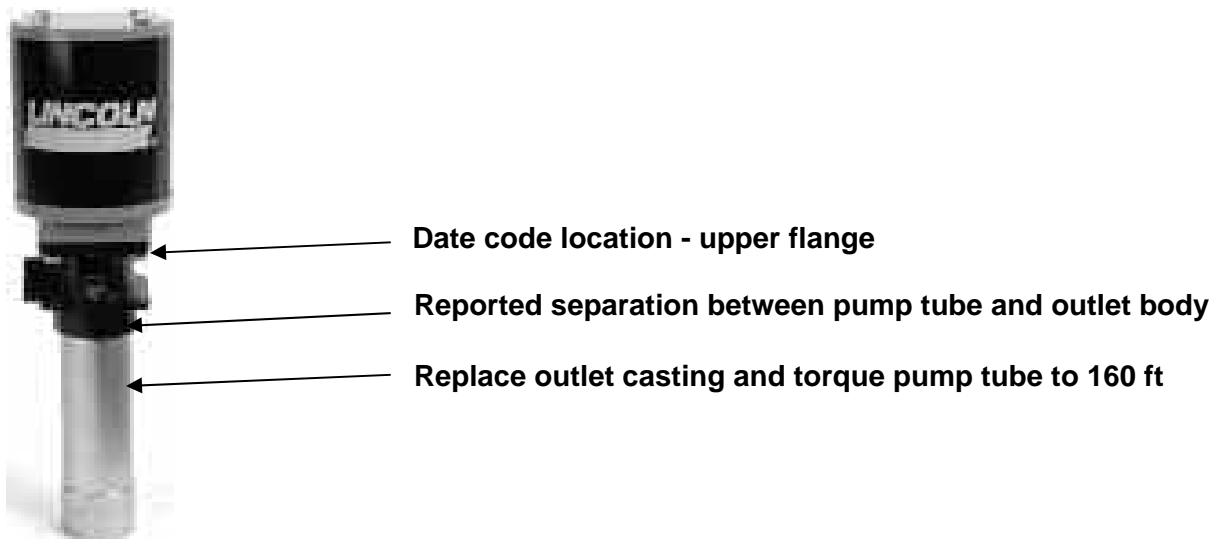
Fig. 2

The torque problem was isolated to pumps that were produced prior to December, 2008. They will be identified with our date code of **ME/XT (12/08) or earlier**. A blue stamp on the shipping carton identifies pumps from these date codes that have been checked and tightened to specification with Loctite 242. Pumps with a manufacturing date code **after ME/XT (12/08)**, or those with the blue dot stamp on the carton have the correct torque and Loctite applied. Please see **FIG. 1** for details of the "MERCHANTSX" date code system used for the PMV pumps. The date code is located on the upper flange of the outlet casting (**see Fig. 2**). Contact us if you have trouble identifying the date code on your pumps.

or pull apart during normal use (threads on the outlet body became distorted and by the time the issue was recognized could not be retightened to the proper torque settings).

b. On pump for installed units- Check for leakage or seepage between outlet casting and pump tube (see Fig.2)

--a. On stock pumps place in vise and loosen the pump tube 5 or 6 turns. Clean the threads with Loctite Prep or another cleaning solution. Dry the threads off. Add 2 to 3 drops of Loctite 242 Blue. Let it cure a couple minutes and re-tighten to 160 ft. lbs.

--b. On installed pumps, if they are leaking or seeping oil or not: take pressure off of pump, loosen the tube 4 or 5 turns. Clean off the threads on the tube with Loctite thread prep or another cleaning solution. Dry threads off completely. Add 2 or 3 drops of Loctite 242 Blue. Let it cure a couple minutes and re-tighten to 160 ft. lbs.
