TECHNICAL SERVICE BULLETIN

Bulletin Number: DC-2257

Subject: Separation Issues between Tube and Outlet Body

Subject: Outlet Body/Pump Tube Torque Settings

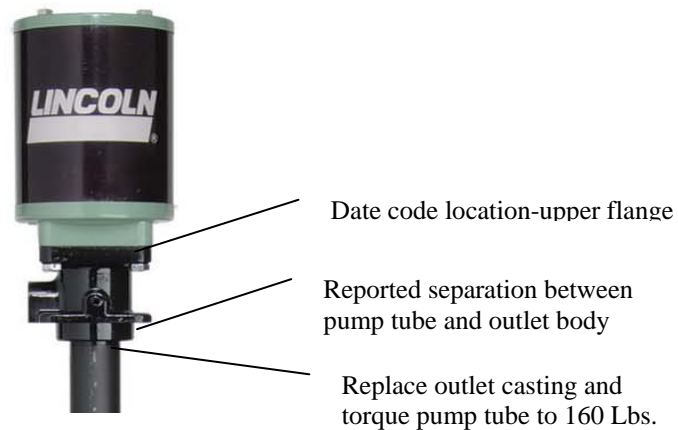
Fig. 2

The reported issues were found to be limited to units that were produced prior to November, 2007. They are identified with our date codes prior to MM/XN (11/07). Please see [Fig. 1](#) for details of our date coding system. It is commonly referred to as the "MERCHANTSX" date code system. If you have any trouble identifying the date code on your pumps, please feel free to contact us. The date code is located on the upper flange of the outlet casting ([see Fig. 2](#)).
