## **TECHNICAL SERVICE BULLETIN**

**Bulletin Number:** DC-2171

**Affected Model(s):** 84803, 84804, and 94804 Air Motors and Associated PM III Pump Assemblies

**Subject:** 241789 Adapter Failures

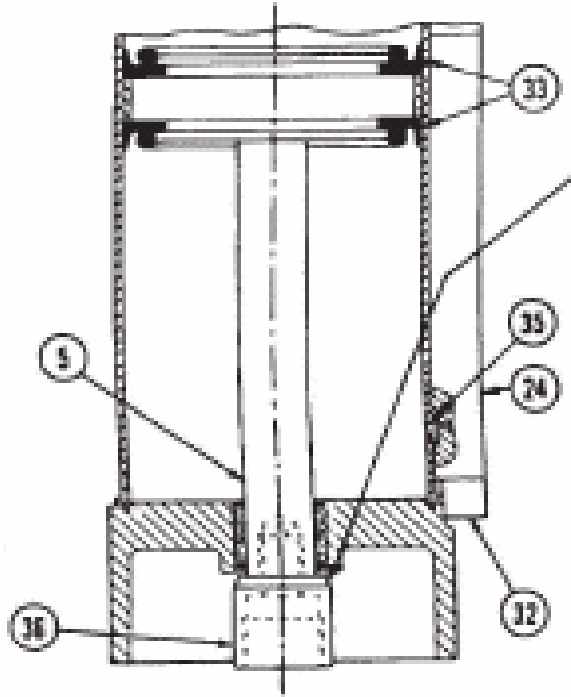
**MODELS 84803 and 84804**

Extensive research of the issue by our Quality Assurance and Engineering departments was under taken, and the mutually agreed upon reason for the failures was the lack of recommended Loctite on the male threads that screw into the air motor piston rod assembly. Our best judgment as to what was occurring is that since little or no Loctite was applied to the adapters, they started working themselves loose. At some point, during the pushing and pulling, or up and down strokes, the adapter becomes tilted or off centered and a stress load is induced on the 241789 adapter. This slight misalignment induced on the adapter makes it the weak link between the air motor and pump tube. Due to the cyclic load on the male thread area of the adapter, the throat area of the adapter begins to crack and continues to crack until a total failure occurs.

During any service repair of the air motor/pump tube assembly, careful attention should be paid to the notation in the service page (see attached "dotted line" depiction).

**-Assemble Adapter to Piston Rod  
-Use Loctite 242 Blue on threads.  
-Torque to 60-65 Ft. Lbs.**
