TECHNICAL SERVICE BULLETIN

Bulletin Number: DC-2205

**Affected Model(s): Bare 282396, 3:1 and 84933, 5:1 Fluid Pumps
(Associated Configured Models)**

Subject: 230001 Fluid Piston Replacement Kit

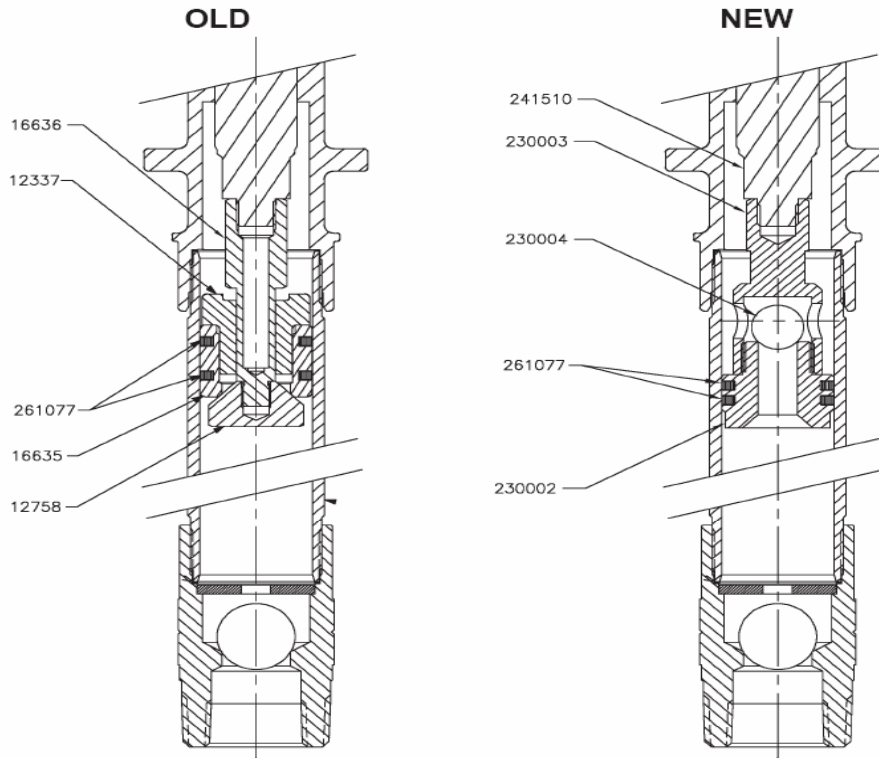
MODEL 230001 Piston Replacement Kit

THE PREVIOUS PISTON ASSEMBLY CONSISTING OF PARTS 12768, 16636, 12337 AND 16635 WITH PACKINGS 261077 WILL BE REPLACED BY PISTON REPLACEMENT KIT PN 230001 WHICH INCLUDES 230004, 230003 AND 230002 WITH PACKINGS 261077.

COMPONENT PART NO.	COMPONENT PART NO.	ASSOCIATED TORQUE (+/-1%)	LOCTITE REQ'D.
241510	230003	10 FT LBS	ONE DROP #242
230003	230002	10 FT LBS	ONE DROP #242
